## -Tree Protection Plan-

### CUBES SELF STORAGE

17414 State Route 527  
Mill Creek, Washington

Prepared for: PacLand  
Prepared by: Washington Forestry Consultants, Inc.  
Date: May 24, 2018

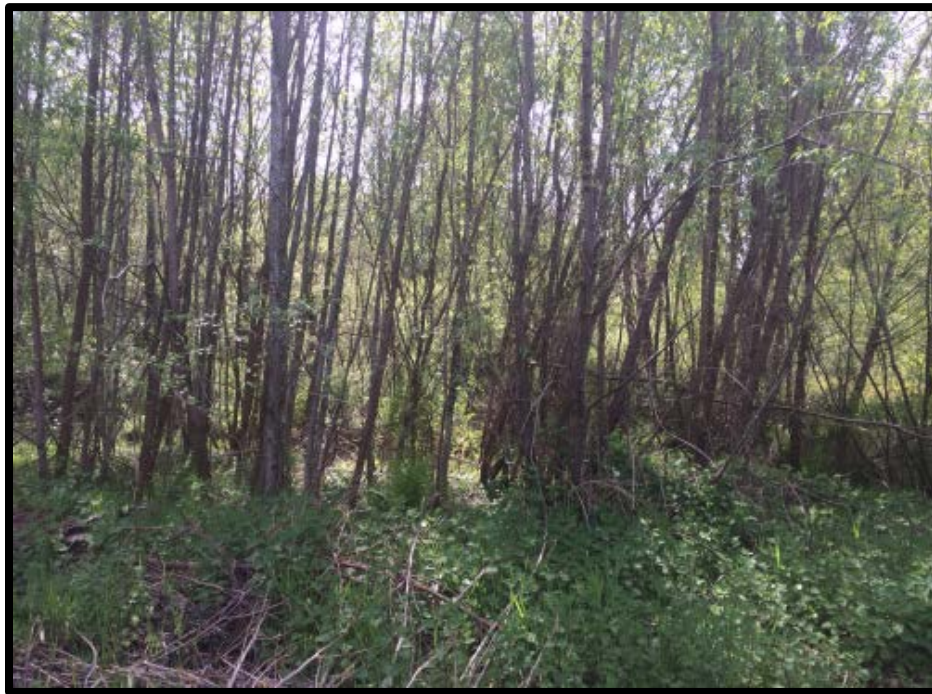
Wetland and It's Buffer. -- Tree species in the wetland area and its buffer include red alder (*Alnus rubra*), black cottonwood (*Populus trichocarpa*), Scouler's willow (*Salix scouleriana*), curly willow (*Salix matsudana*), western redcedar (*Thuja plicata*), and Pacific willow (*Salix lucida*). Tree size ranges from 6 to 33 inches DBH. Tree condition ranges from 'Very Poor' to 'Fair', with most trees described as being in 'Poor' or 'Very Poor' condition.

**Photo 1:** Appearance of trees in wetland area, most of which are under 6 in. DBH

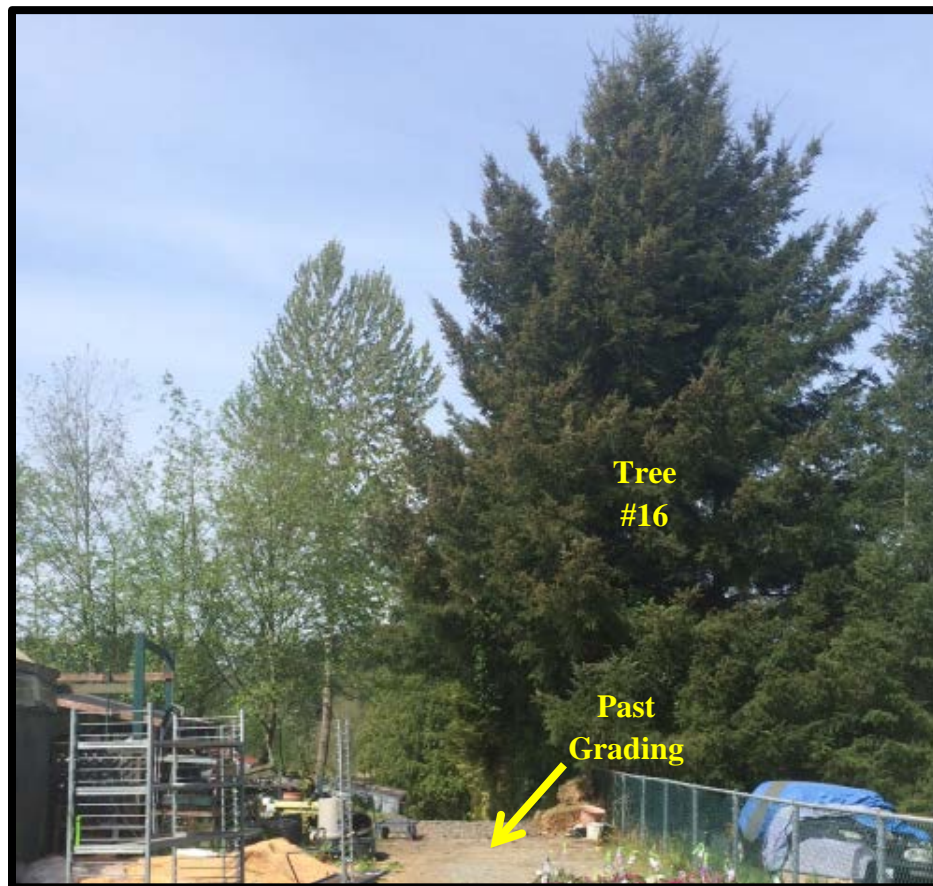
Three trees growing on the parcel to the north of the project area could be impacted by construction of the project. Some grading has already occurred in the vicinity of two of these trees. Further excavation could potentially cause these trees to decline. These 3 trees will require protection during the construction of the storm water facility.

**Photo 2:** View of off-site tree #14. Grading has already occurred in its vicinity. Further disturbance should be avoided in this area.

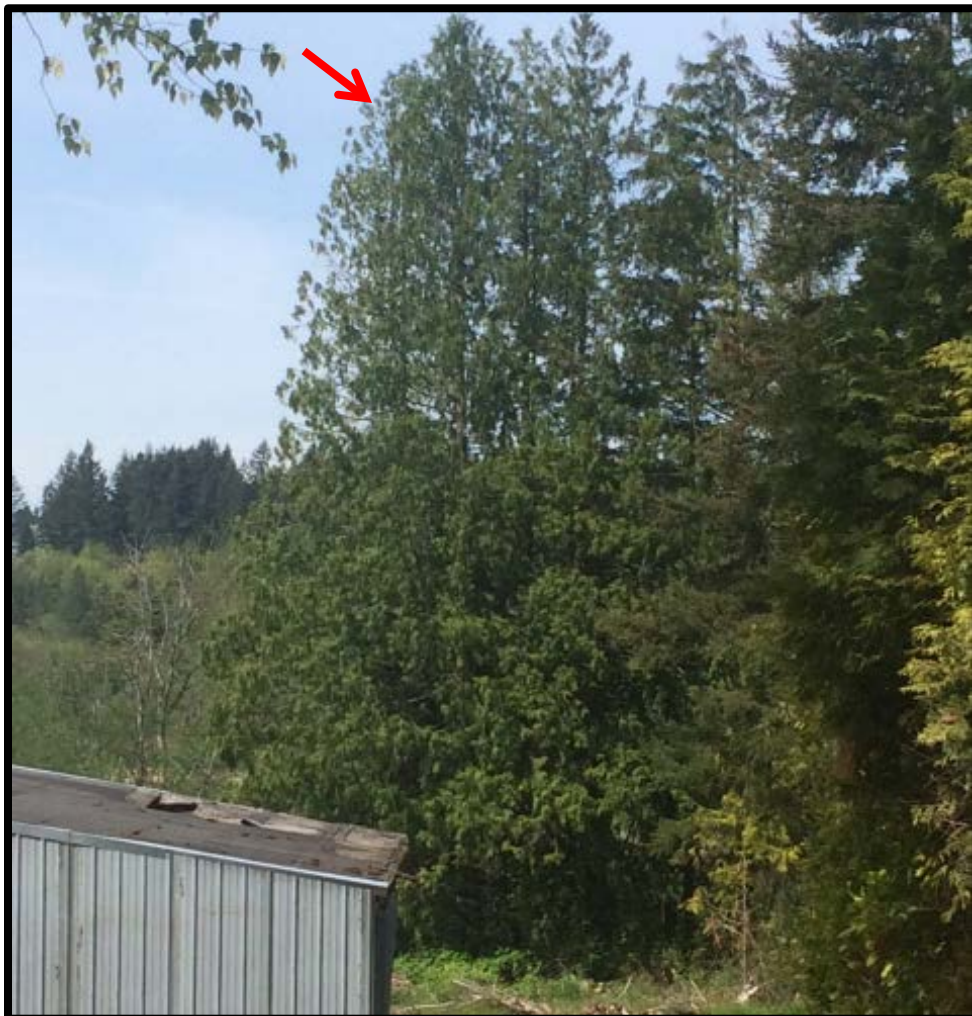
The area that offers the best potential for tree retention is a portion of the buffer area in the northwest corner. Four large western redcedar trees (see Photo 2) that grow near the proposed storm water facility will require protection from the impacts of construction.

**Photo 2:** View of 4 western redcedars near proposed storm water facility

Trees to be saved must be protected during construction by a six foot high chain link fencing (Attachment 4), located at the edge of the critical root zone (CRZ). Placards shall be placed on the fencing every 50 feet indicating the words, "NO TRESPASSING - Protected Trees". The individual CRZ are a radius of one foot for each one inch of DBH (6 feet minimum), unless otherwise delineated by WFCI (see Attachment 3).
