-Tree Protection Plan-

VINTAGE at MILL CREEK

132nd Street SE
Mill Creek, WA

Date: February 2, 2015

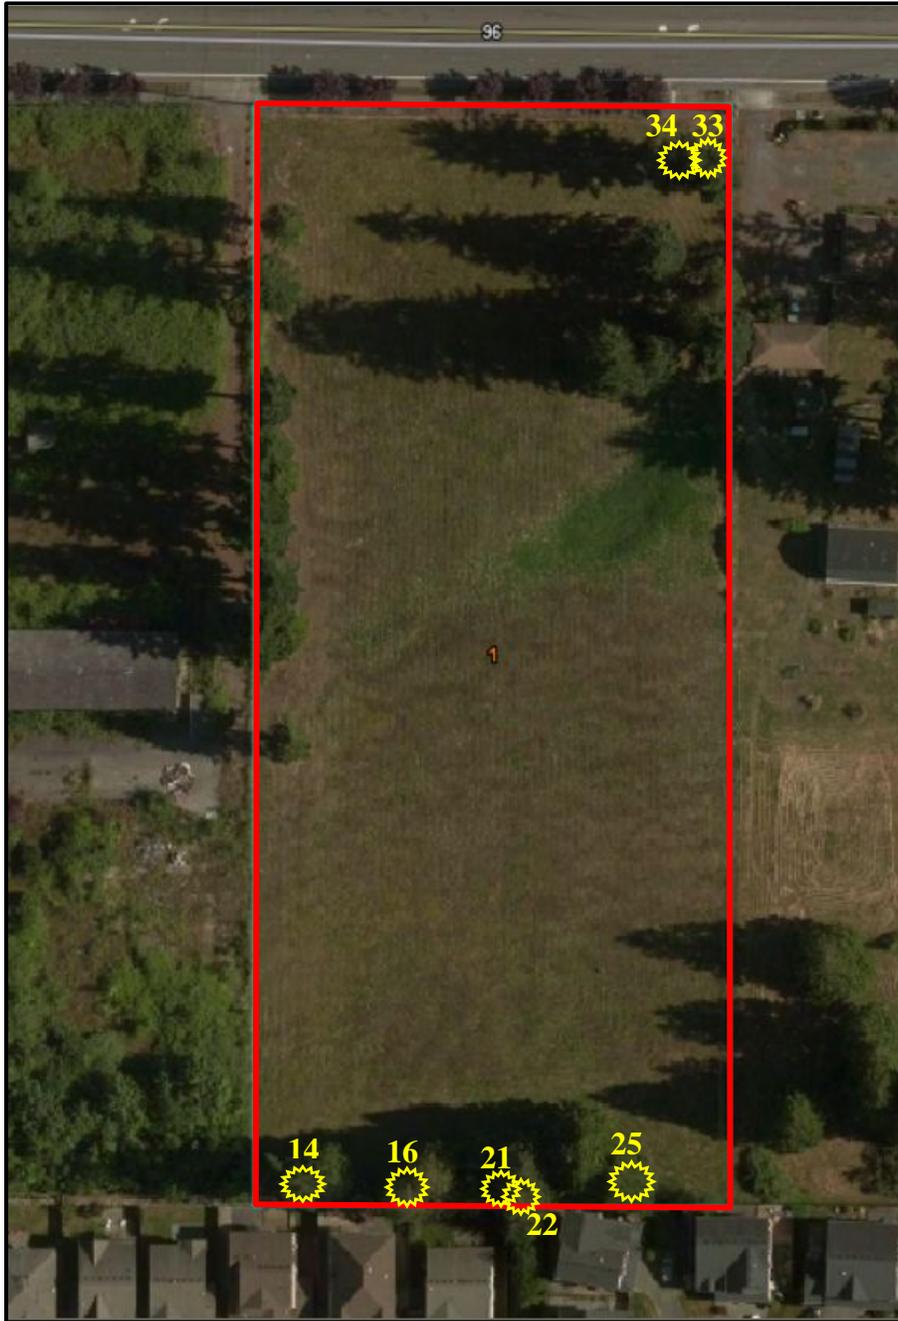
**Attachment #1: Aerial Photo of Vintage @ Mill Creek
with Potential Save Trees Identified
(USDA Web Soil Survey Photo)**

The first area has two Douglas-fir trees that could be saved (tree # 33 & 34) if space is provided in the project. They are in the northeastern corner of the property.

The other potential tree save area is along the southern property line. Given that the prevailing winds are from the south, and the roots would be impacted on the north side of the trees, this may be acceptable. Up to 20% of the roots can be impacted.

Trees to be saved must be protected during construction by a six foot high chain link fencing (Attachment #7), located at the edge of the critical root zone (CRZ). Placards shall be placed on the fencing every 50 feet indicating the words, "NO TRESPASSING - Protected Trees". The individual CRZ are a radius of one foot for each one inch of DBH (6 feet minimum), unless otherwise delineated by WFCI (see Attachment #3).
